June 28, 2019  
File No. 262018.063

Subject: Department of Natural Resources Washington Geological Survey,  
School Seismic Safety Assessment Project, Contract No. AE 410 -  
Seismic Evaluation for **North Beach School District**

### **School Buildings Evaluated in the North Beach School District**

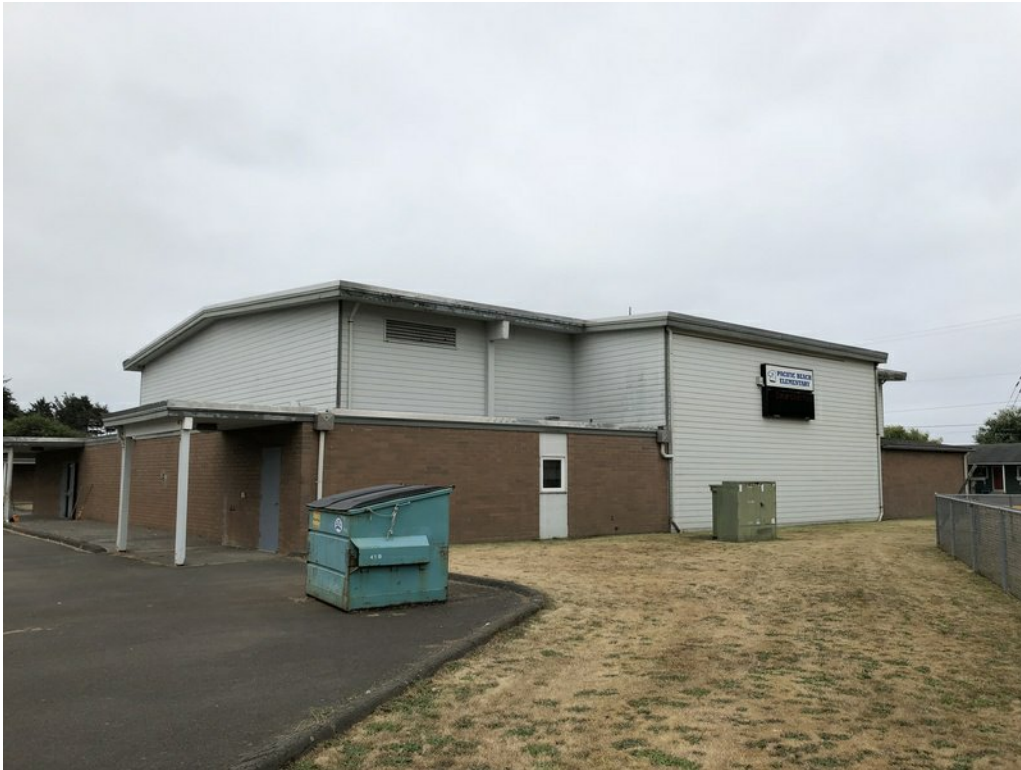
Figure 1-1. Northeast Corner

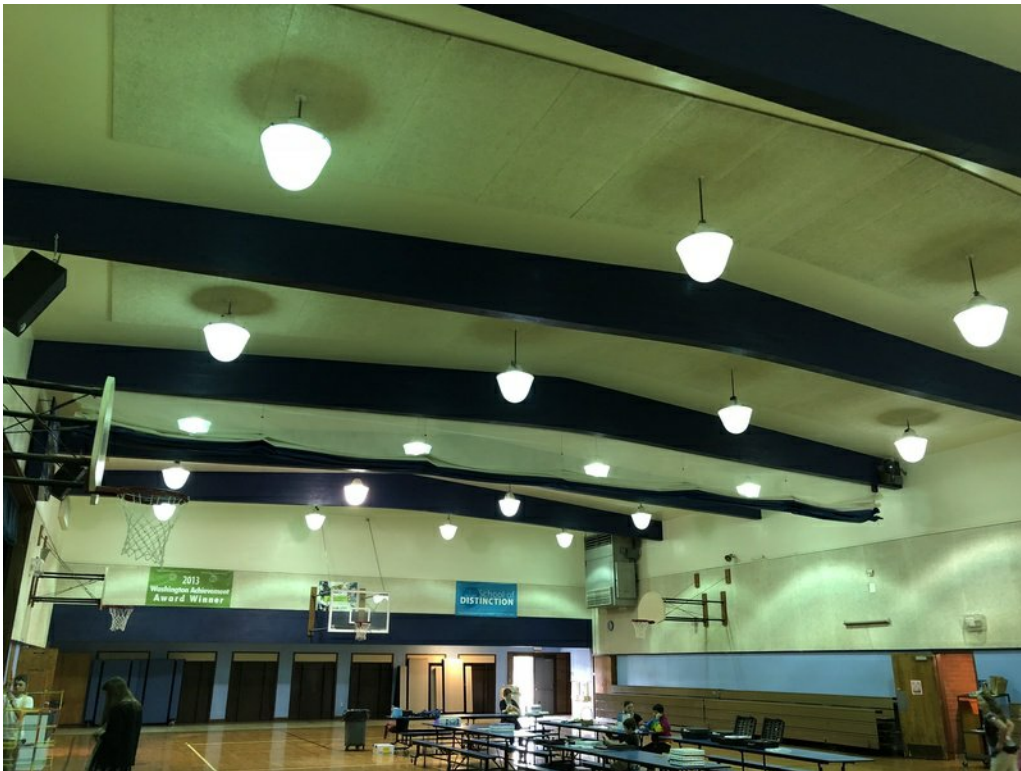
Figure 1-2. Gym Roof Framing

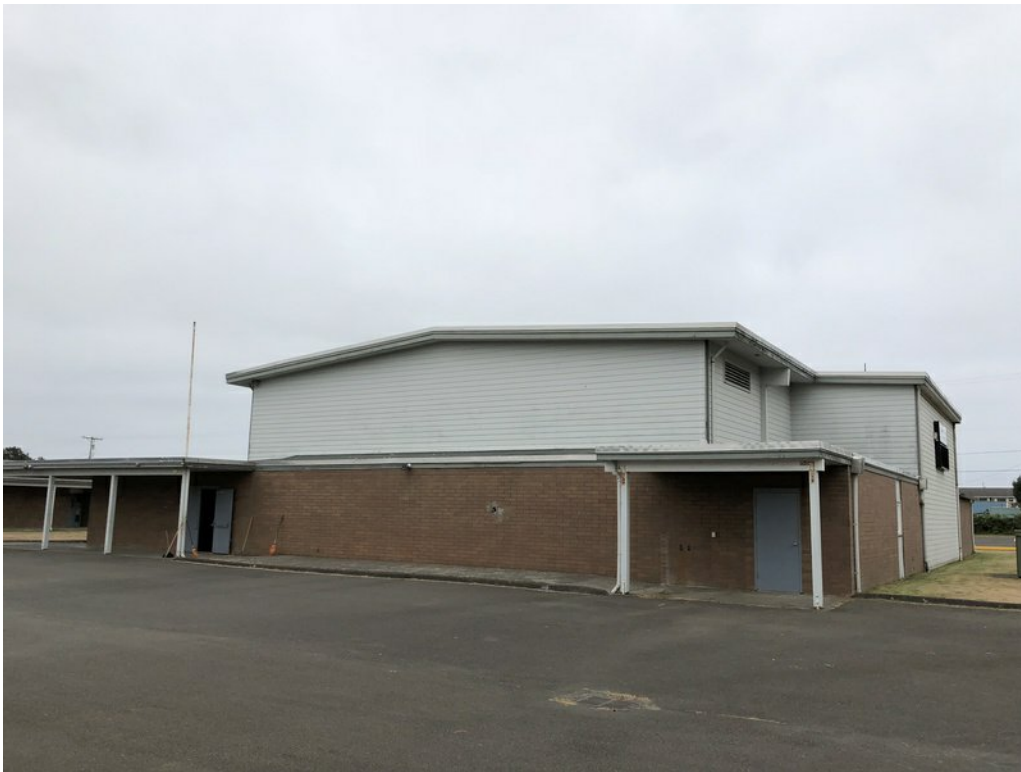
**Figure 1-3. East Elevation**

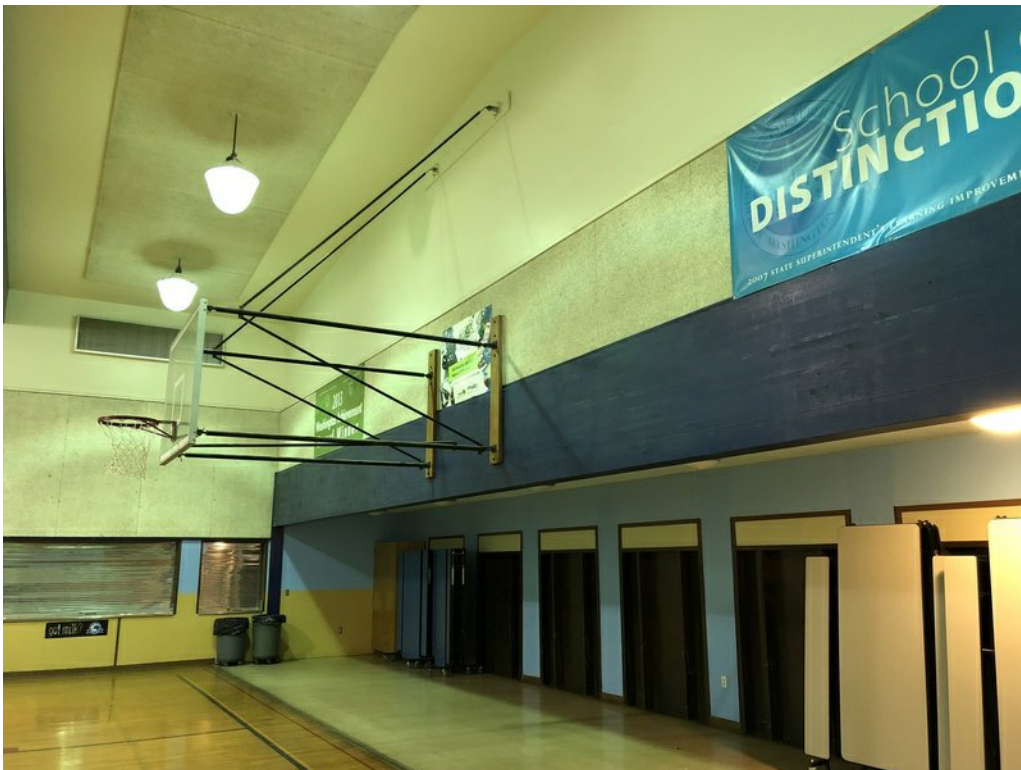
**Figure 1-4. Transfer Beam at East Side of Gym**

Vertical Irregularities	All vertical elements in the seismic-force-resisting system are continuous to the foundation. (Tier 2: Sec. 5.4.2.3; Commentary: Sec. A.2.2.4)		X			East Wall of Gym is discontinuous. Supported by transfer beam. Further investigation should be performed. Transfer beam strengthening or additional shear walls may be appropriate to mitigate seismic risk.
Geometry	There are no changes in the net horizontal dimension of the seismic-force-resisting system of more than 30% in a story relative to adjacent stories, excluding one-story penthouses and mezzanines. (Tier 2: Sec. 5.4.2.4; Commentary: Sec. A.2.2.5)			X		The building is a one story structure.
Mass	There is no change in effective mass of more than 50% from one story to the next. Light roofs, penthouses, and mezzanines need not be considered. (Tier 2: Sec. 5.4.2.5; Commentary: Sec. A.2.2.6)			X		The building is a one story structure.

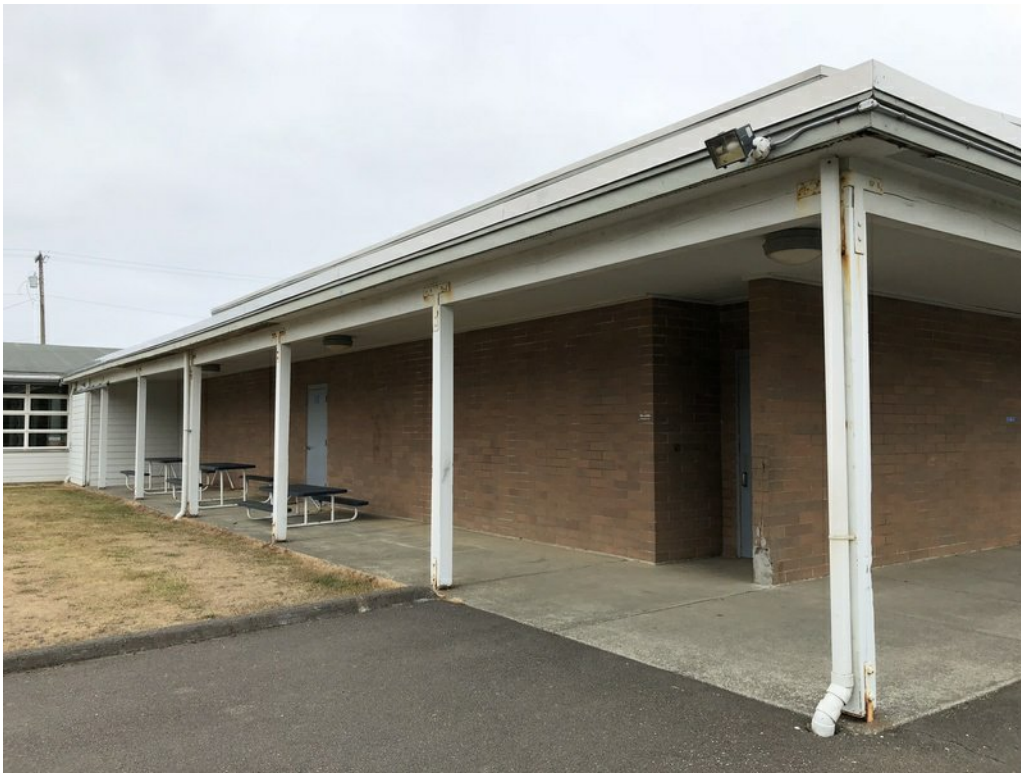
Figure 1-5. South masonry wall and canopy

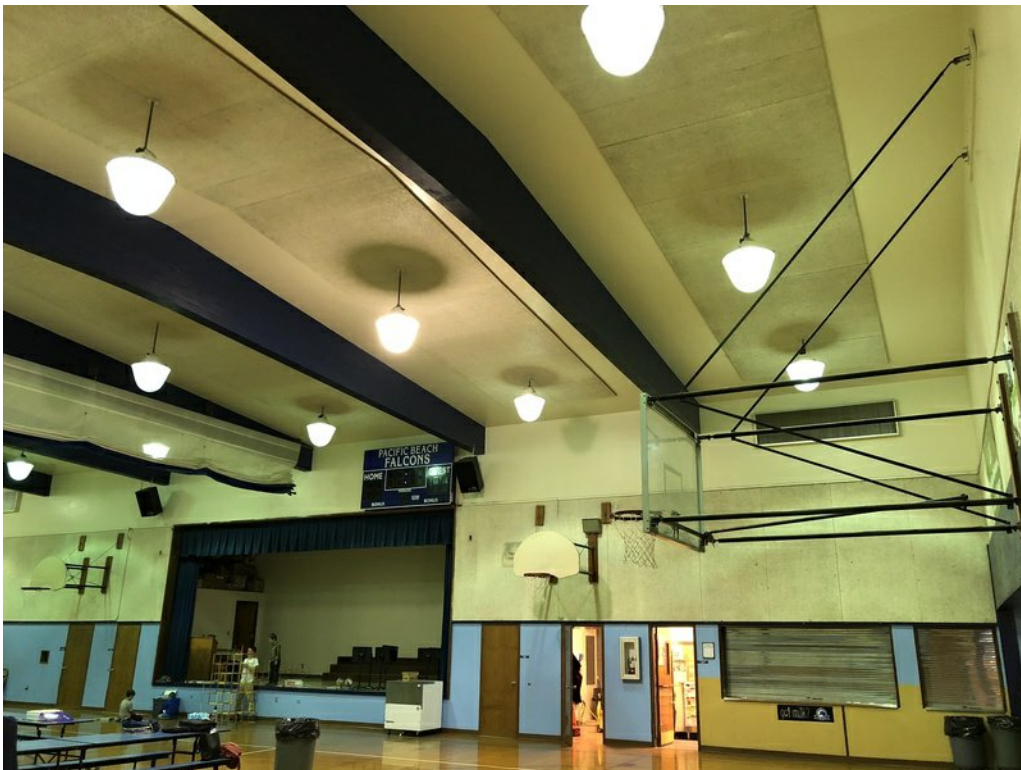
Figure 1-6. Gymnasium roof framing

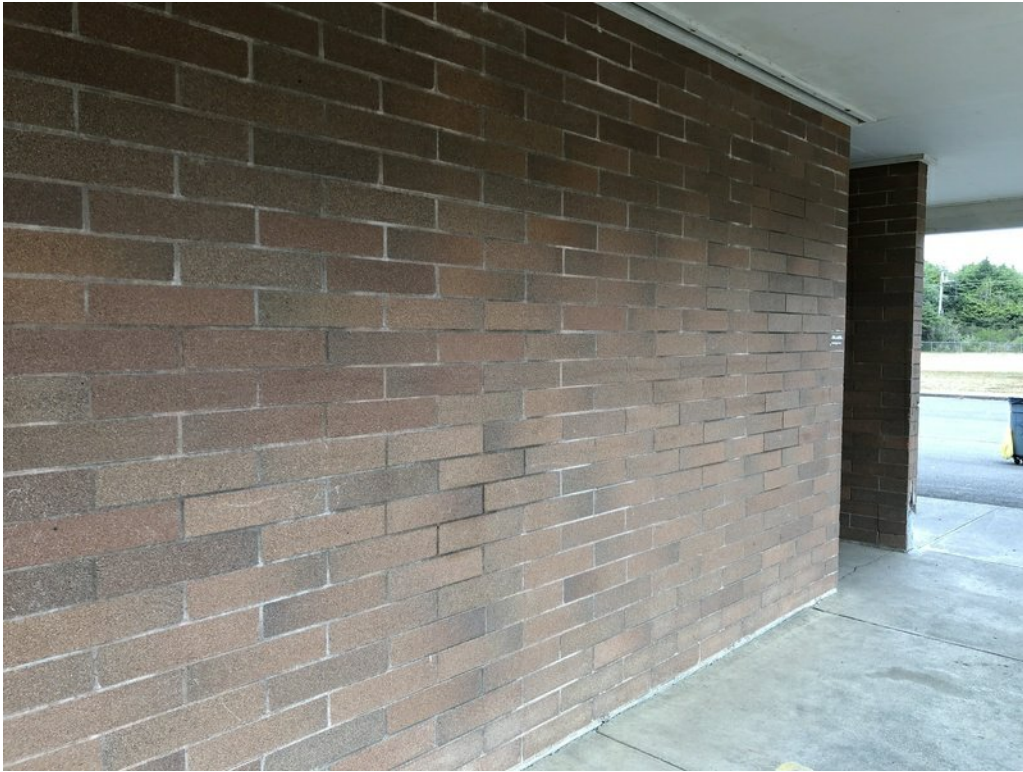
**Figure 1-7. Brick masonry wall at south elevation**

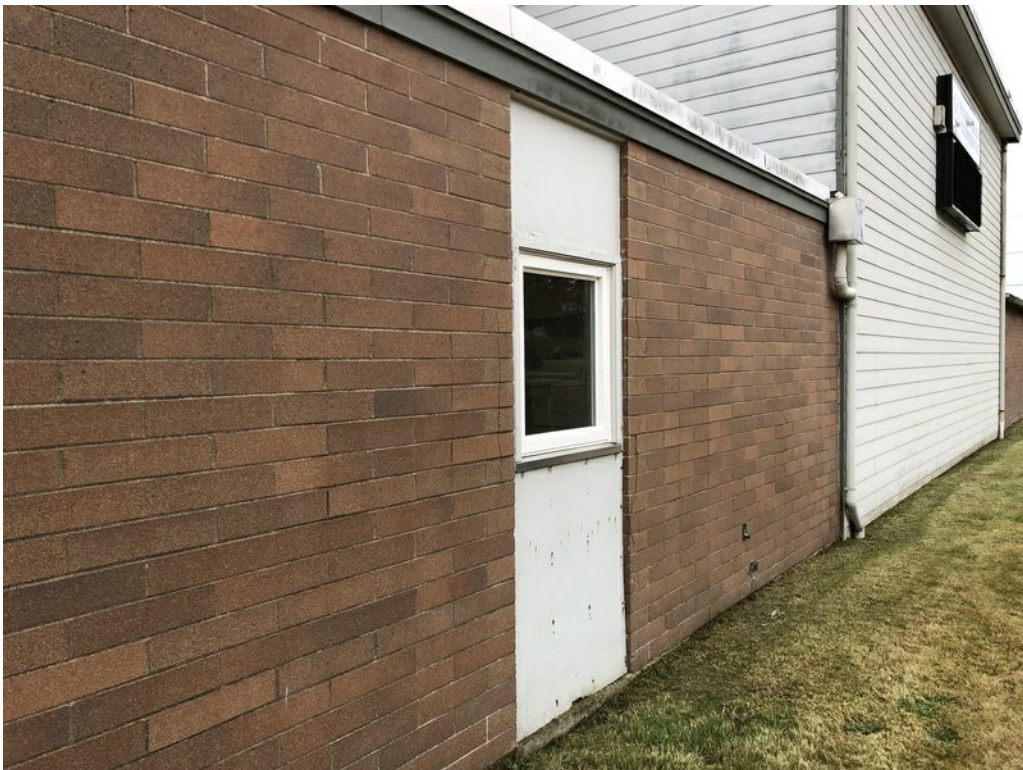
**Figure 1-8. Brick walls at the North Elevation**

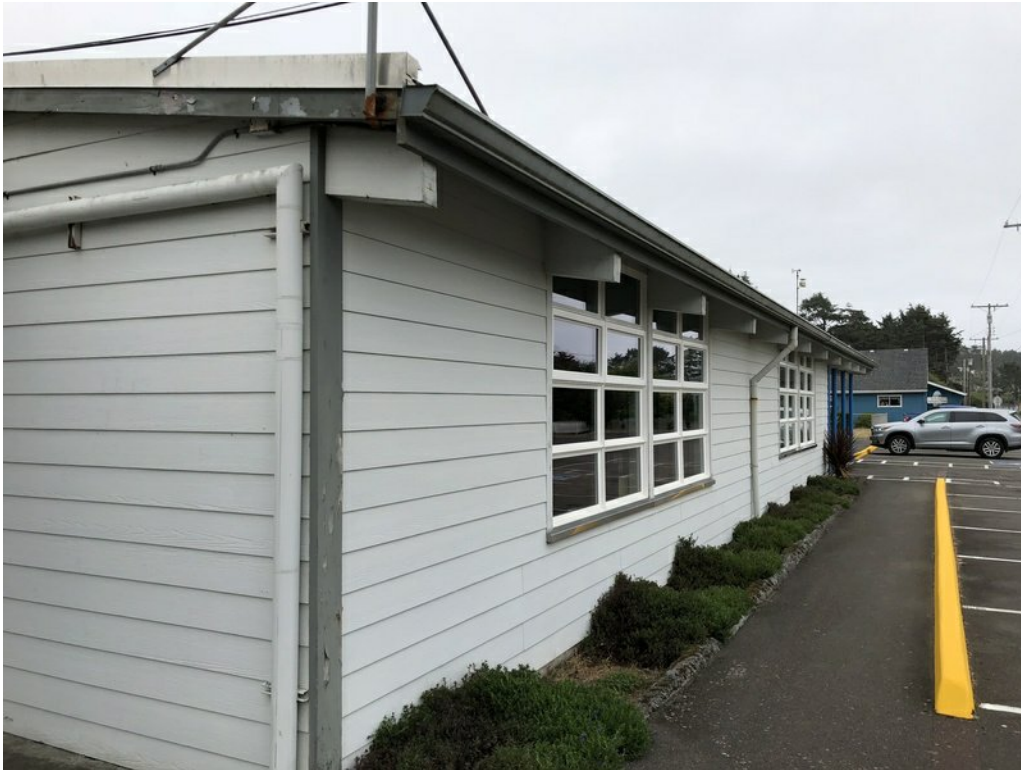
**Figure 1-1. Exterior Elevation at Typical Classroom**

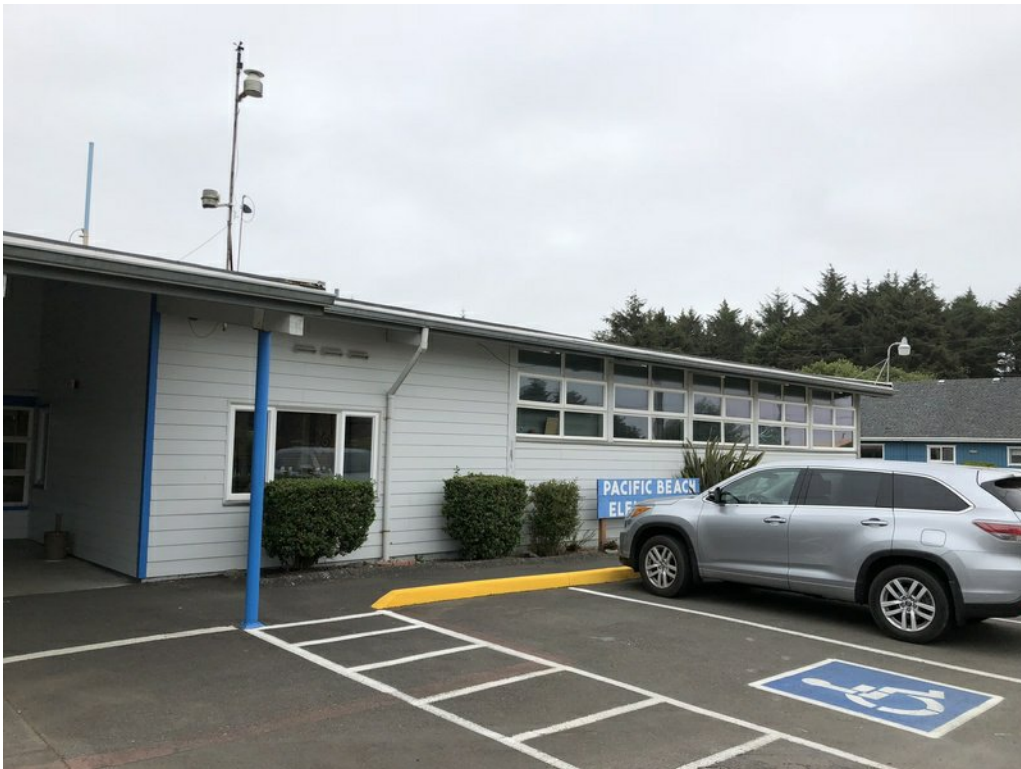
**Figure 1-2. West Elevation at Main Building**

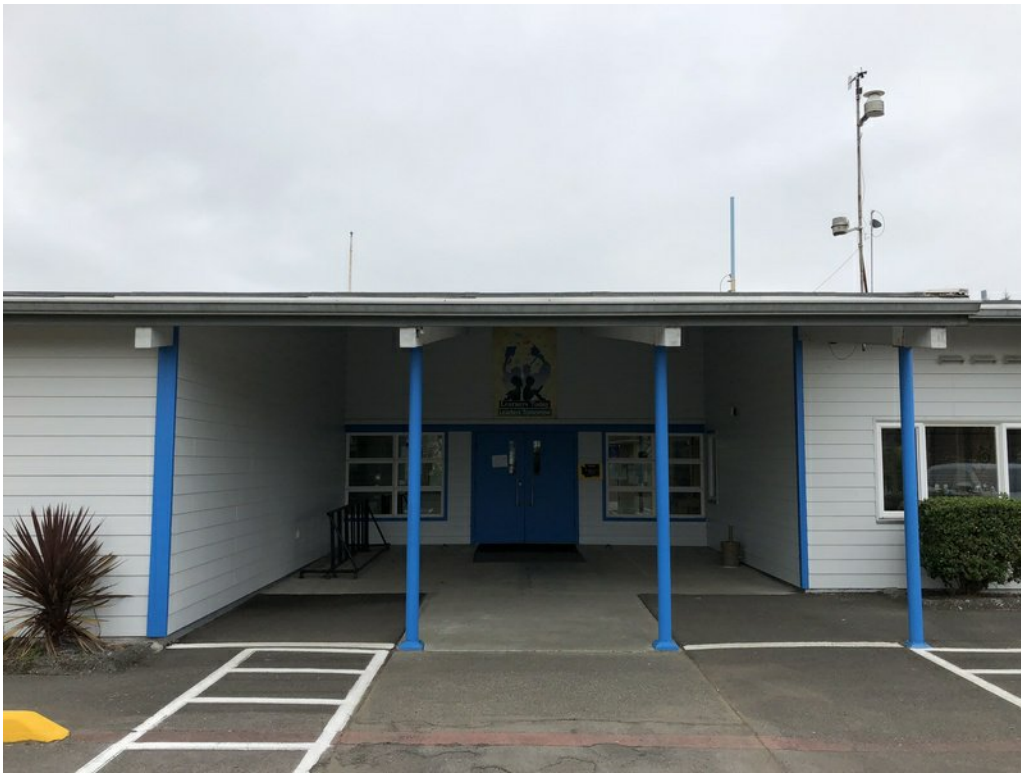
**Figure 1-3. Main Entrance**

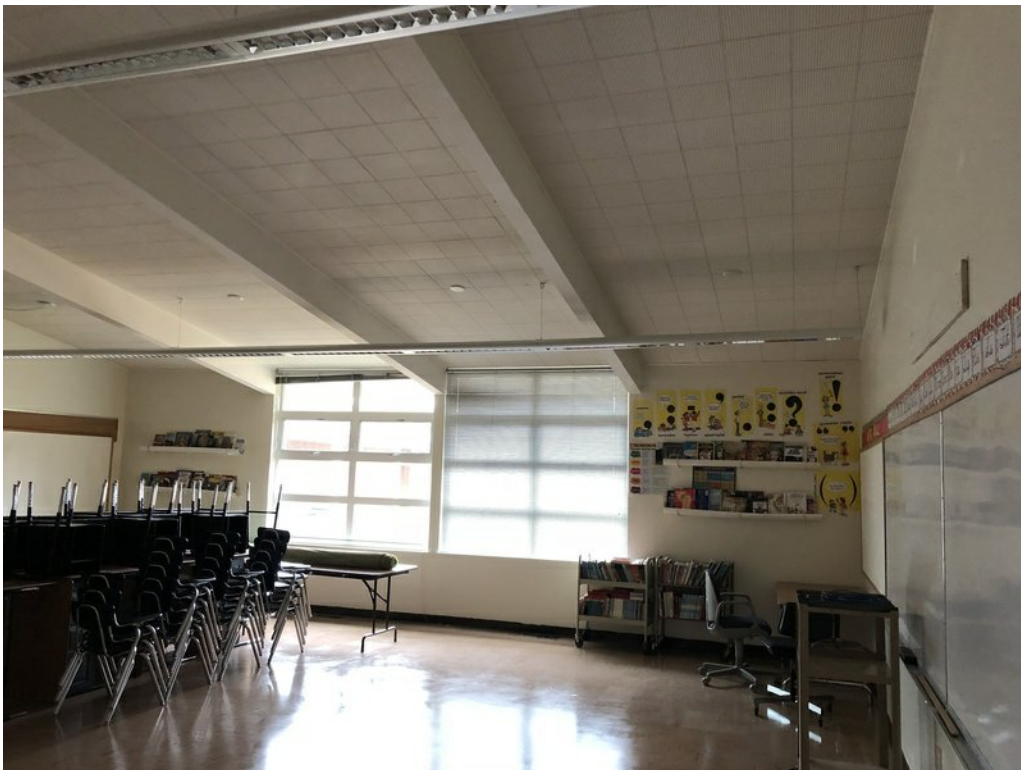
**Figure 1-4. Roof Framing at Classroom**

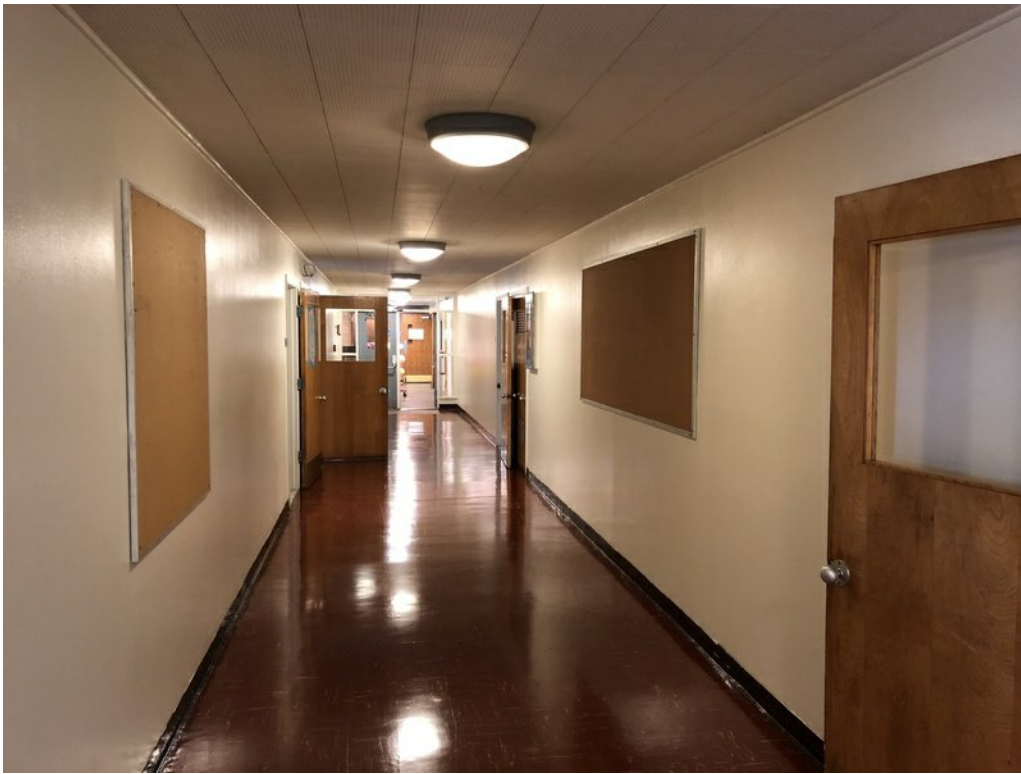
**Figure 1-5. Corridor Walls at Main Building**

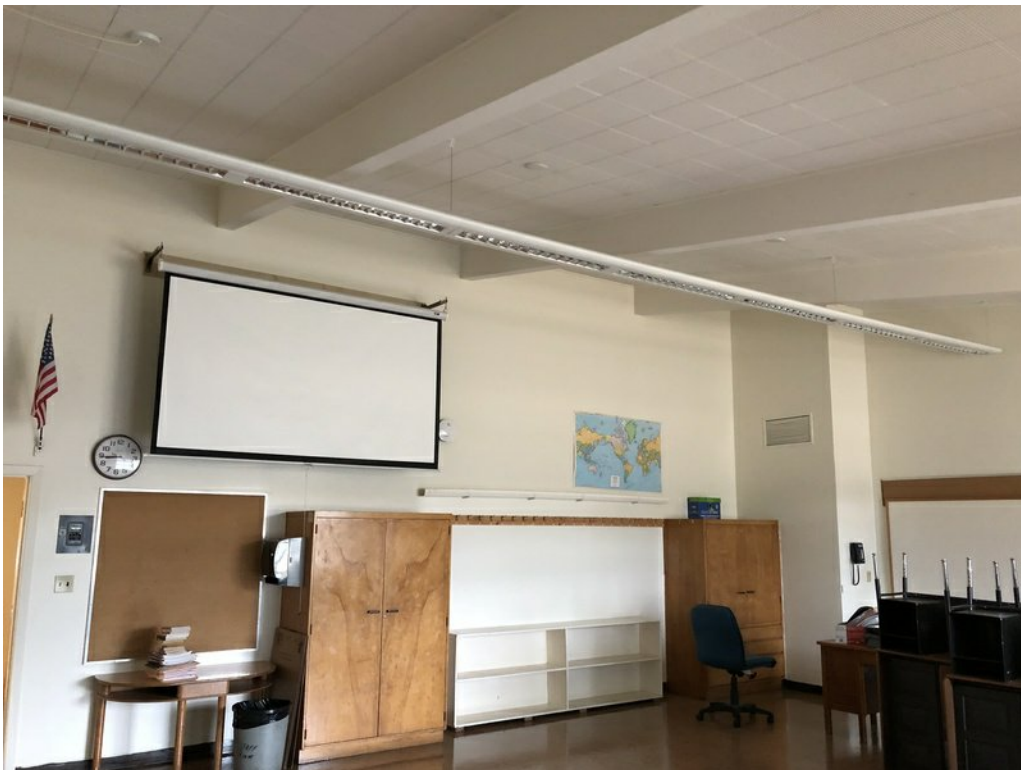
**Figure 1-6. Classroom Interior Wall**

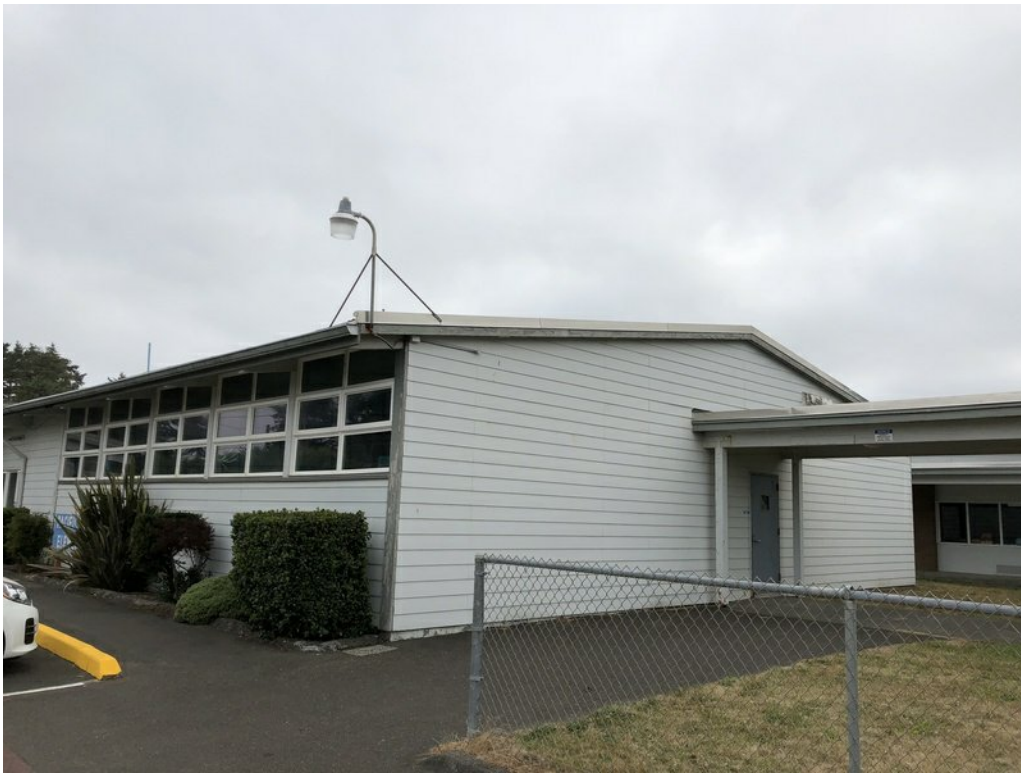
**Figure 1-7. Southwest elevation**

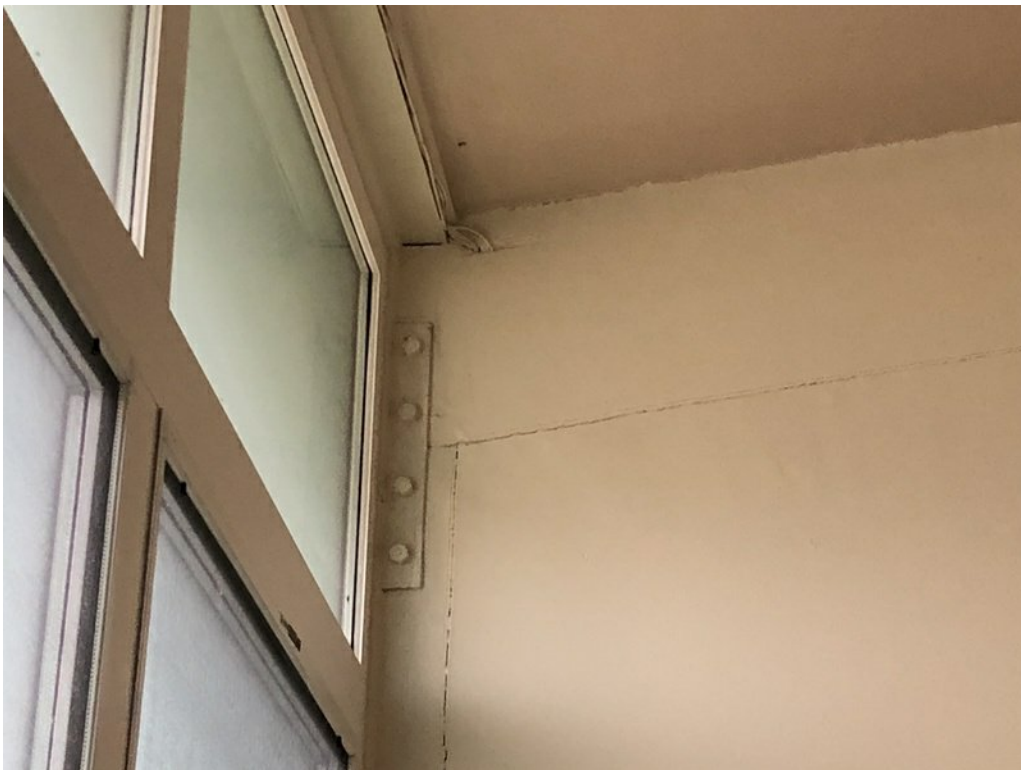
**Figure 1-8. Beam connection to post in wall**

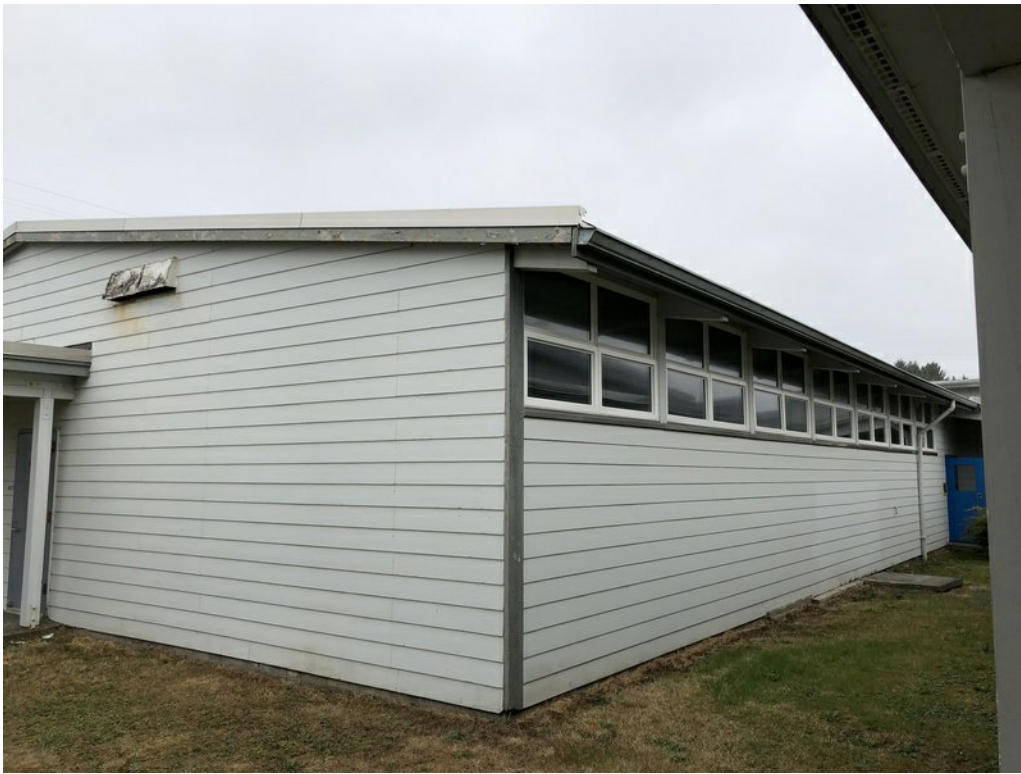
**Figure 1-9. Southeast Elevation**

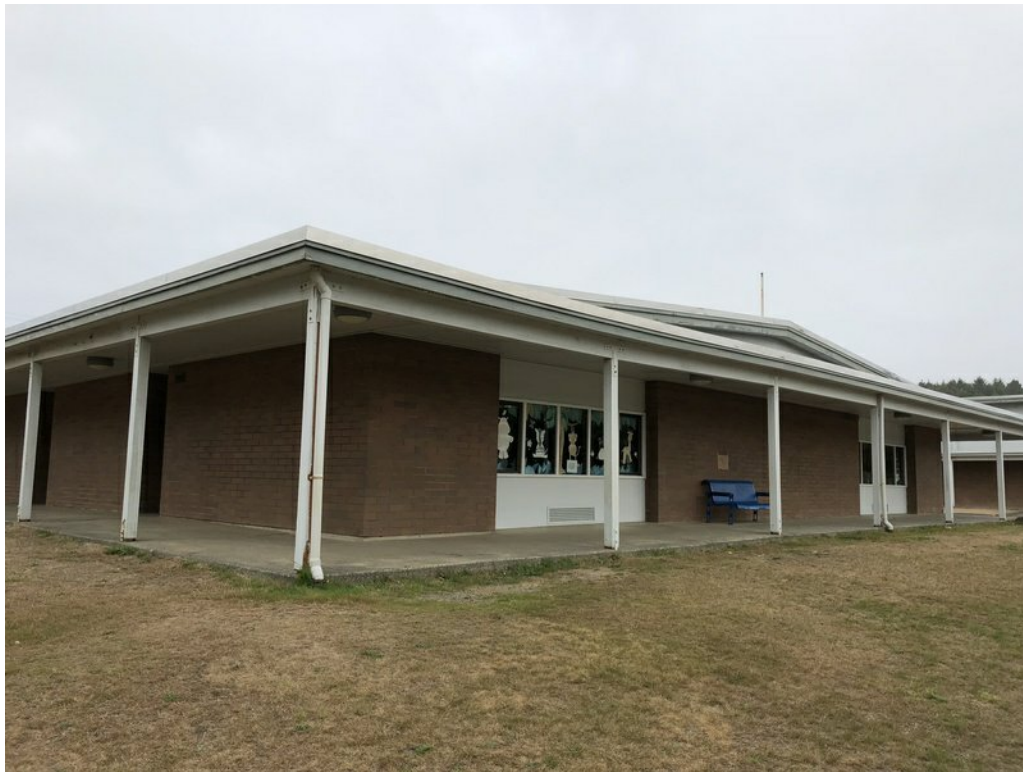
**Figure 1-1. Southeast Elevation**

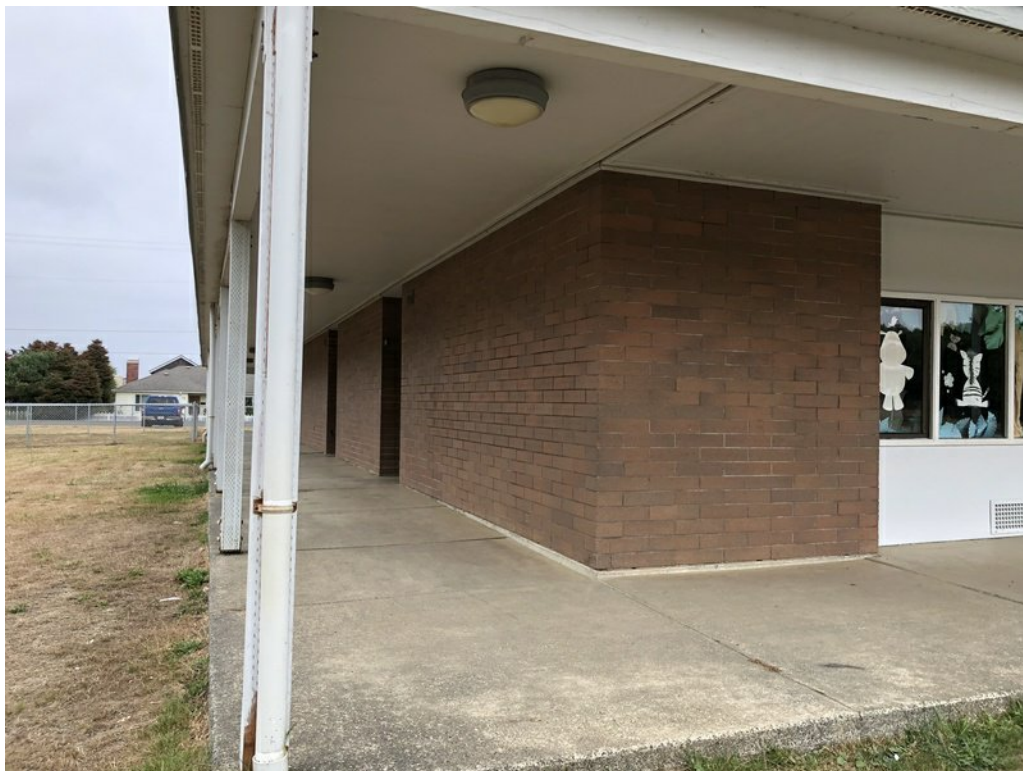
**Figure 1-2. Brick Masonry Walls**

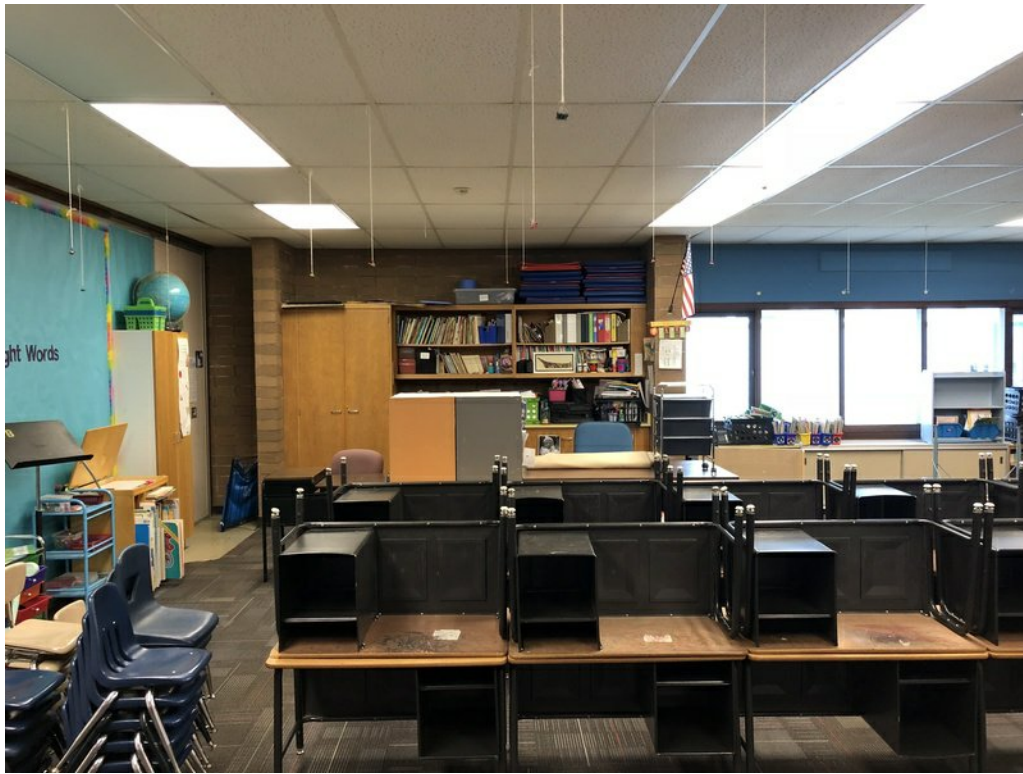
Figure 1-3. Interior Classroom

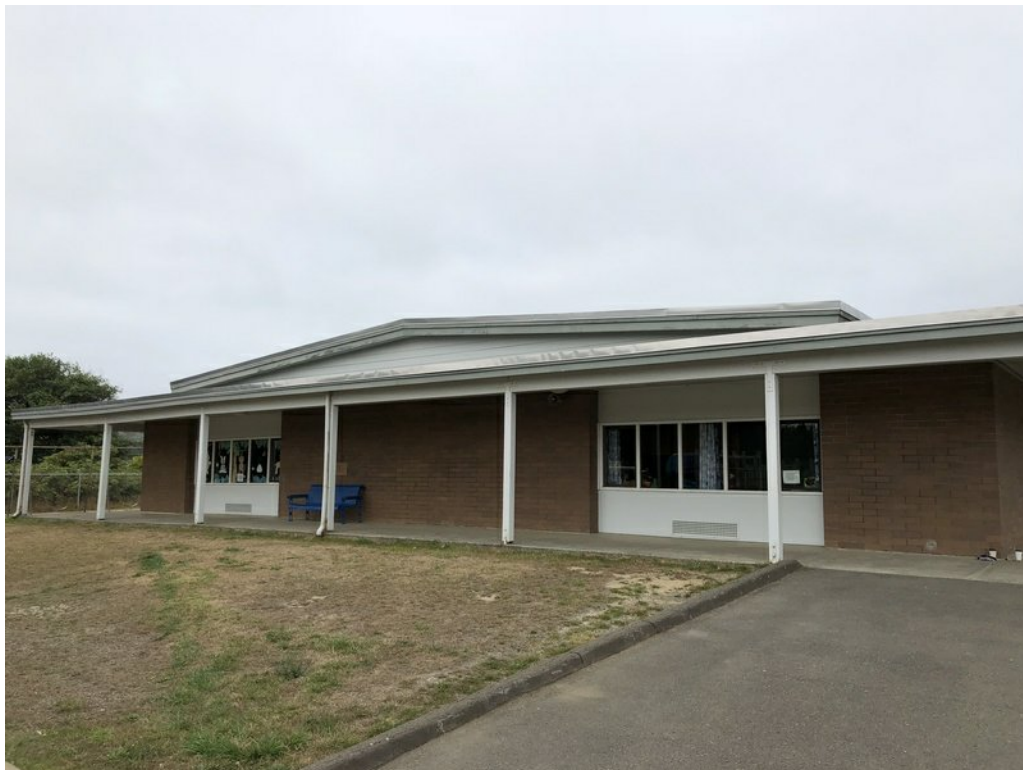
Figure 1-4. South Elevation

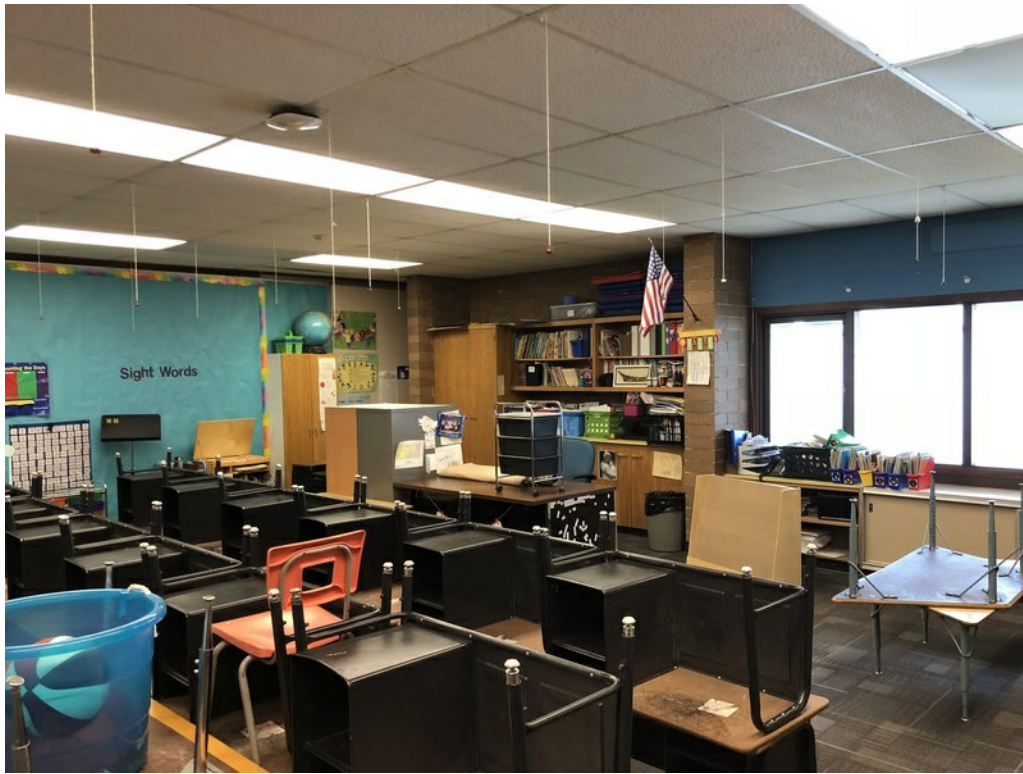
Figure 1-5. Interior Classroom

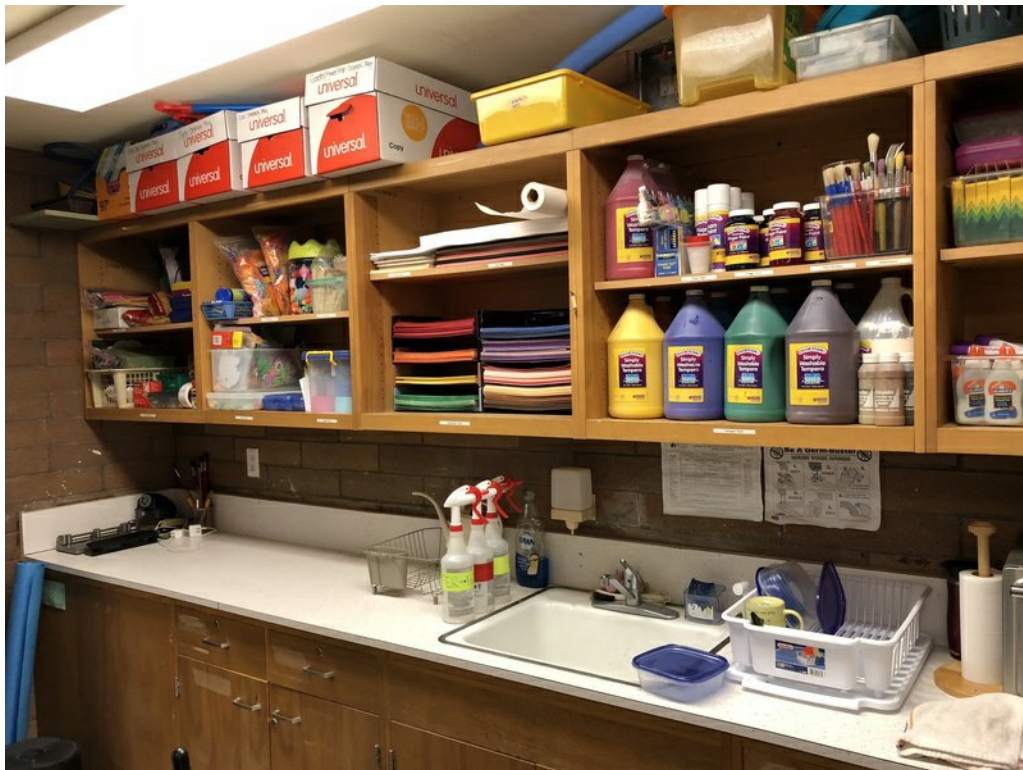
Figure 1-6. Supply and Cleaning Room

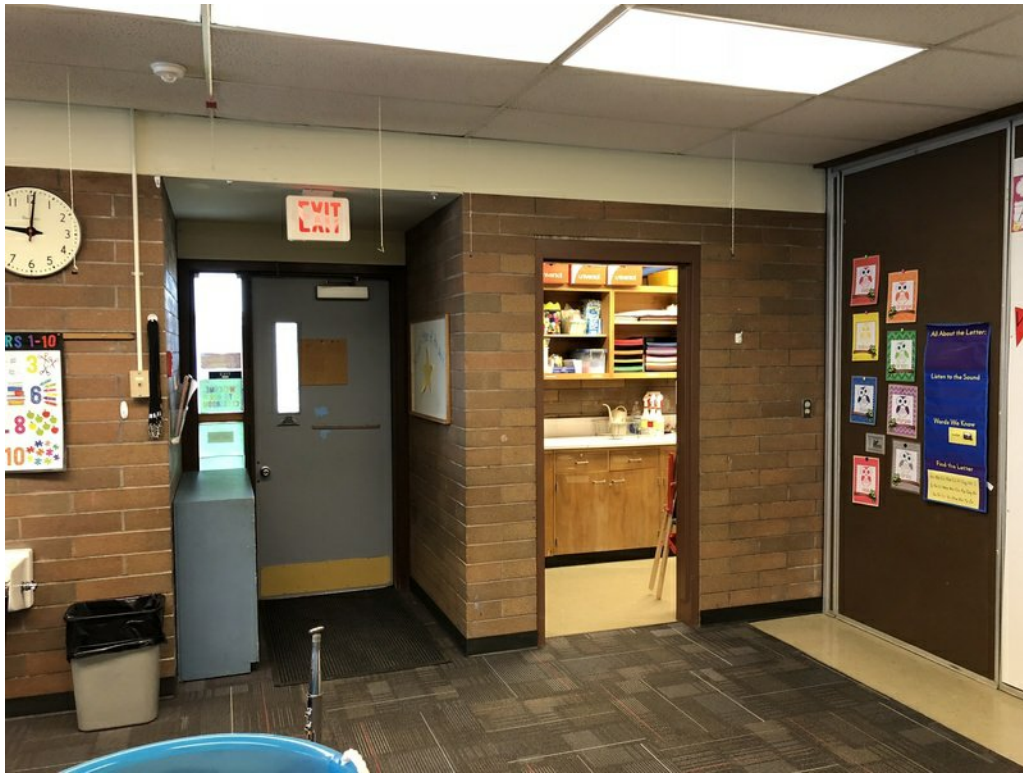
**Figure 1-7. Interior Masonry Walls**
